# REPORT

Type	<b>SUV</b>
Make	<b>BMW</b>
Model	<b>X6</b>
Engine capacity [ccm]	<b>2998</b>
Power [kW]	<b>279</b>
VIN	<b>XXXXXXXXXXXXXXXXXXXX</b>
Fuel Type	<b>Gas</b>
Year of production	<b>2024</b>
Mileage	<b>45.000 km</b>
Paint color	<b>Black metallic</b>
Paint type	<b>Original manufacturer's paint</b>
Number of owners	<b>1</b>
Paint condition	<b>Minor scratches on the driver's door</b>
Service history	<b>No accidents</b>
Additional comments	<b>No visible body and paint repairs</b>
First registration	<b>01.01.2024</b>
Windows condition	<b>Original manufacturer's windows</b>
Painting history	<b>Fully original paint</b>

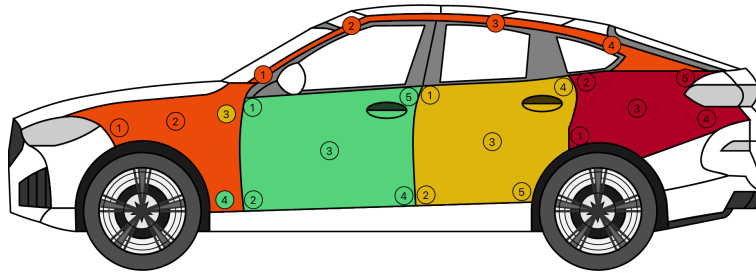
## PAS: general interpretation, body

LEFT SIDE											
	Coating	Minimum	Maximum	Medium	1.	2.	3.	4.	5.	6.	7.
left front fender/ bumper	Fe	91	454	308	454	454	231	91	-	-	-
left front door	Fe+Zn	81	81	81	81	81	81	81	81	-	-
left rear door	Fe	226	229	228	229	229	228	227	226	-	-
left pillar	Fe+Zn	453	456	454	456	454	453	453	-	-	-
left rear fender/ bumper	Fe	760	764	762	764	762	762	760	760	-	-

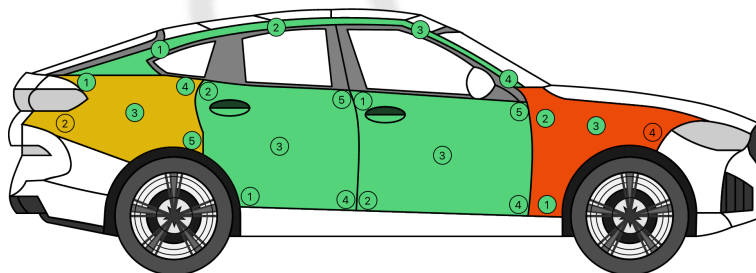
RIGHT SIDE											
	Coating	Minimum	Maximum	Medium	1.	2.	3.	4.	5.	6.	7.
right front fender/ bumper	Fe	83	455	176	83	83	83	455	-	-	-
right front door	Fe	83	84	83	83	84	83	83	83	-	-
right rear door	Fe	84	84	84	84	84	84	84	84	-	-
right pillar	Fe	84	85	85	85	85	85	84	-	-	-
right rear fender/ bumper	Fe	85	231	115	86	231	86	85	85	-	-

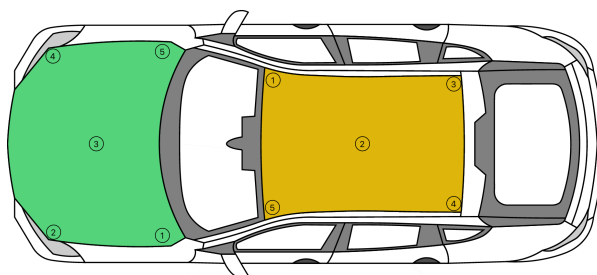
TOP											
	Coating	Minimum	Maximum	Medium	1.	2.	3.	4.	5.	6.	7.
hood/bonnet	Fe	88	90	89	88	90	89	88	88	-	-
roof	Fe	227	233	229	233	229	229	227	227	-	-

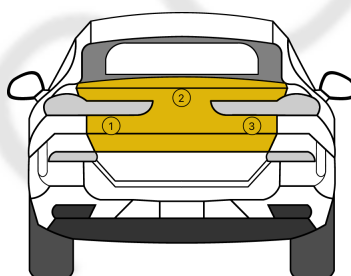
BACK											
	Coating	Minimum	Maximum	Medium	1.	2.	3.	4.	5.	6.	7.
trunk/boot	Fe	226	228	227	228	226	226	-	-	-	-

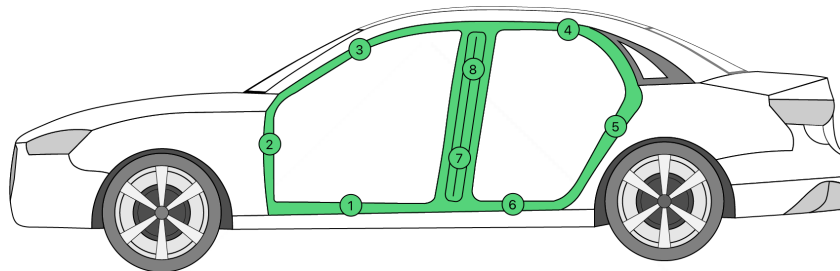
## PAS: general interpretation, internal body parts

LEFT SIDE												
	Coating	Minimum	Maximum	Medium	1. 8.	2. 9.	3. 10.	4. 11.	5. 12.	6. 13.	7. 14.	
Left side	Fe	85	86	85	86 85	86 -	86 -	85 -	85 -	85 -	85 -

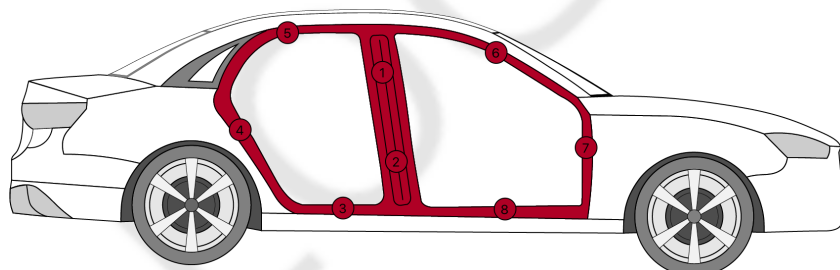
RIGHT SIDE												
	Coating	Minimum	Maximum	Medium	1. 8.	2. 9.	3. 10.	4. 11.	5. 12.	6. 13.	7. 14.	
Right side	Fe	451	800	496	800 451	454 -	453 -	453 -	452 -	451 -	451 -

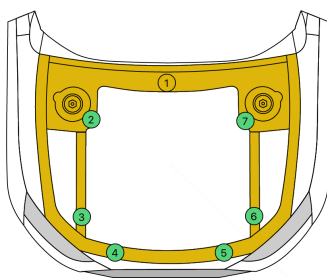
ENGINE COMPARTMENT											
	Coating	Minimum	Maximum	Medium	1.	2.	3.	4.	5.	6.	7.
Engine compartment	Fe	86	92	88	92	89	89	87	87	86	86

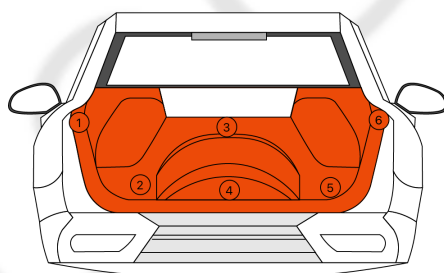
TRUNK/BOOT											
	Coating	Minimum	Maximum	Medium	1.	2.	3.	4.	5.	6.	7.
trunk/boot	Fe	223	236	227	236	227	227	226	224	223	-
